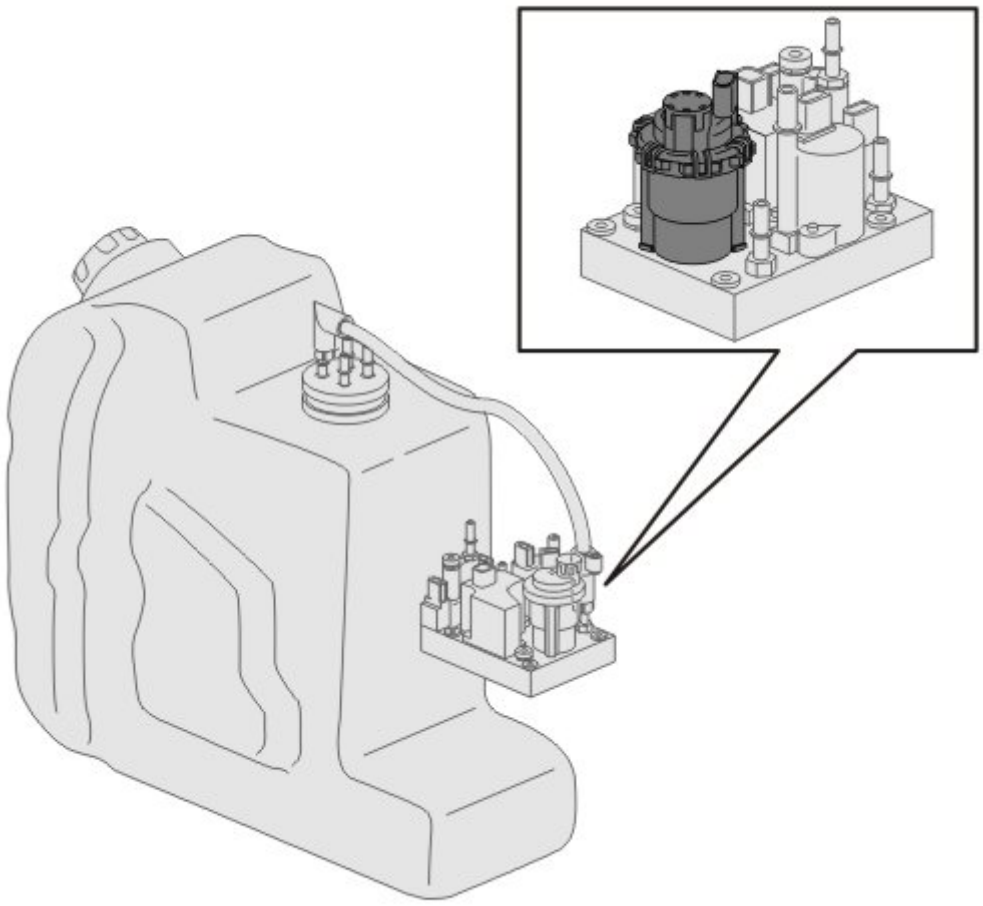
Fault type	Condition for Fault	Observable Symptoms	Possible cause
P208C FTB 00	• The voltage at pin A174.A:20 is below normal value.	• No AdBlue solution dosage.	• Wiring harness. • Short circuit to ground, Control wire (-). • Aftertreatment AdBlue pump. • Aftertreatment Control Module (ACM).

Measuring	Key position	Measurement points		Reference value	Measured value	Other (Special tool No.)
		Breakout box	Wiring diagram			
Short circuit to ground Check	Off	16 – Chassis ground point.	A174.A:16 – Chassis ground point.	R = Open circuit		88890074, 9990014, 9998699

- Disconnect M49 connector and check the DTC status for Active or inactive.
- If shows inactive when disconnected, the fault is in the component instead of the harness.
